CORROSION OF STEEL BRIDGE GIRDER ANCHOR BOLTS

A Thesis
Presented to
The Academic Faculty

Lisa Lindquist

August 2008

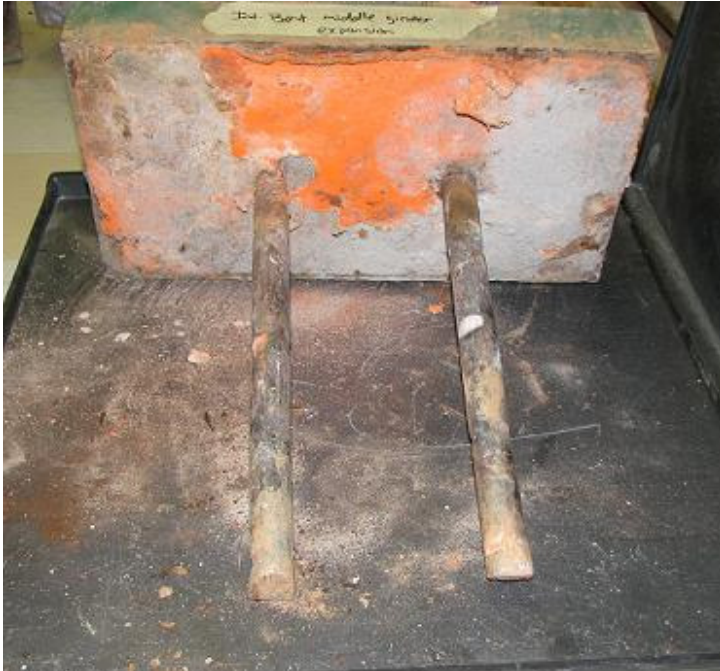
Figure 7.4: Bearing plate and anchor bolts from an interior girder expansion bearing. The expansion slots are not visible because they are completely filled with debris and corrosion products.

In addition to the broken specimens obtained during field investigations, whole anchor bolts and bearing plates were acquired from the demolition of the Old Dixie Highway bridge in Clayton county. A variety of bearing plates and anchor bolts were acquired from fixed and expansion bearings at edge and interior girders. Figures 7.4 and 7.5 show a typical fixed and expansion bearing.

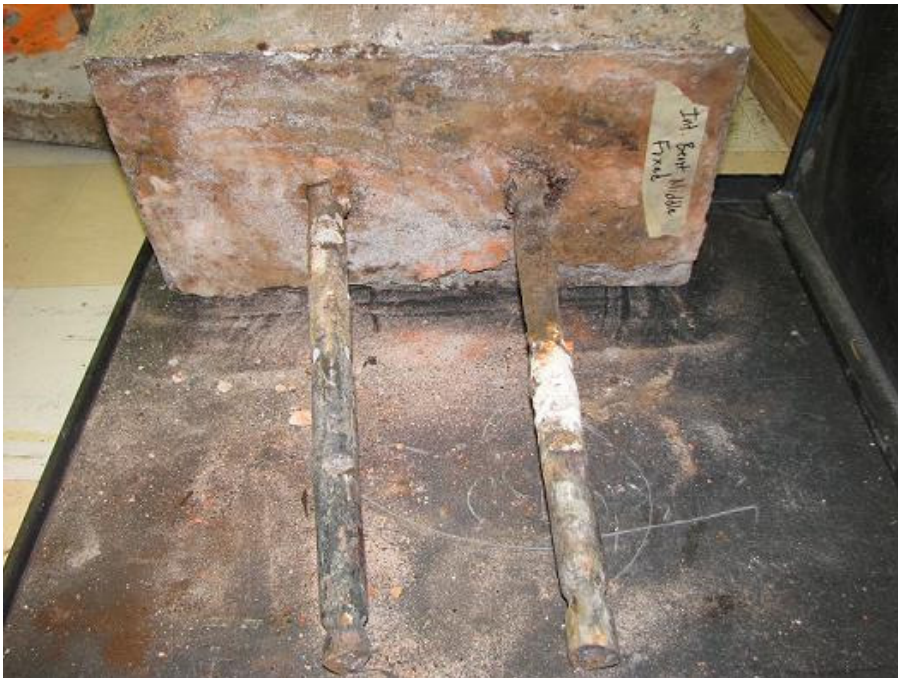
Figure 7.5: Bearing plate and anchor bolts from a fixed bearing.

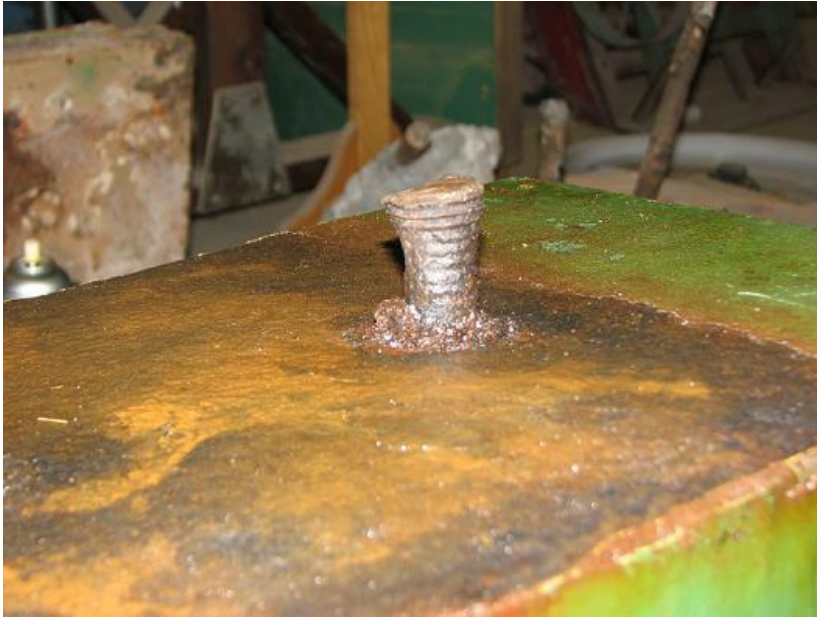
Figure 7.7: Corrosion build-up visible at the interface of the bolt and bearing plate.

A commercially available corrosion debonding product was used in an attempt to disintegrate the corrosion scale. While the anchor bolts were still not freed from the bearing plate, enough corrosion scale was removed to allow the visual examination of the interface of the bolt and the bearing plate, as shown in Figure 7.7.

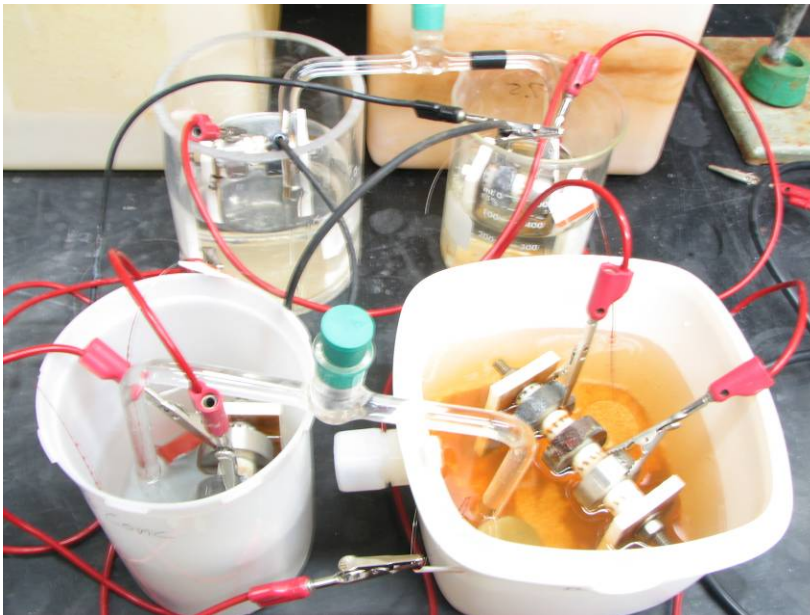
Figure 8.6: Concentration cell coupling of similar metals in solutions with differing pH values. Stainless steel in solution with pH 13 is coupled with stainless steel in solution with pH 7.5, and carbon steel in solution with pH 13 is coupled with carbon steel in solution with pH 7.5.

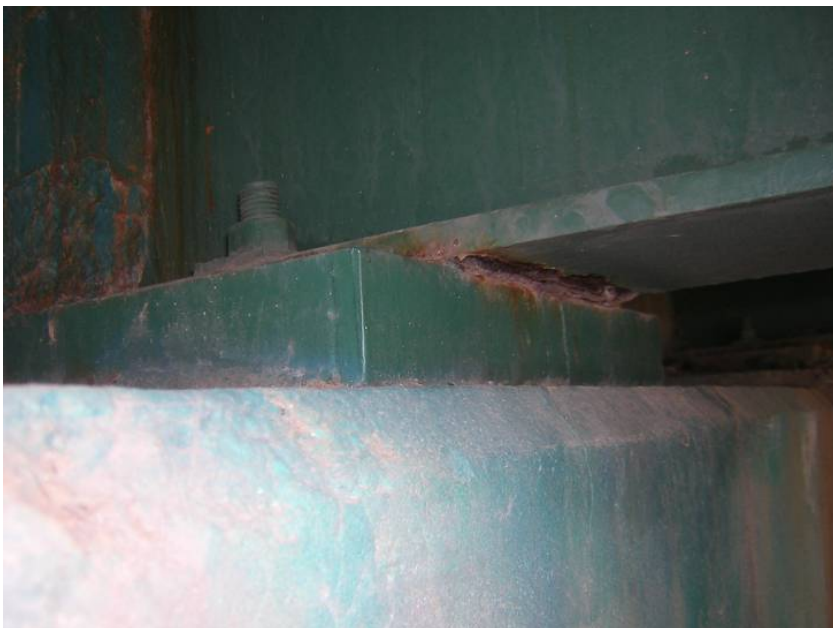
Figure B.4: Corrosion between bearing plate and flange

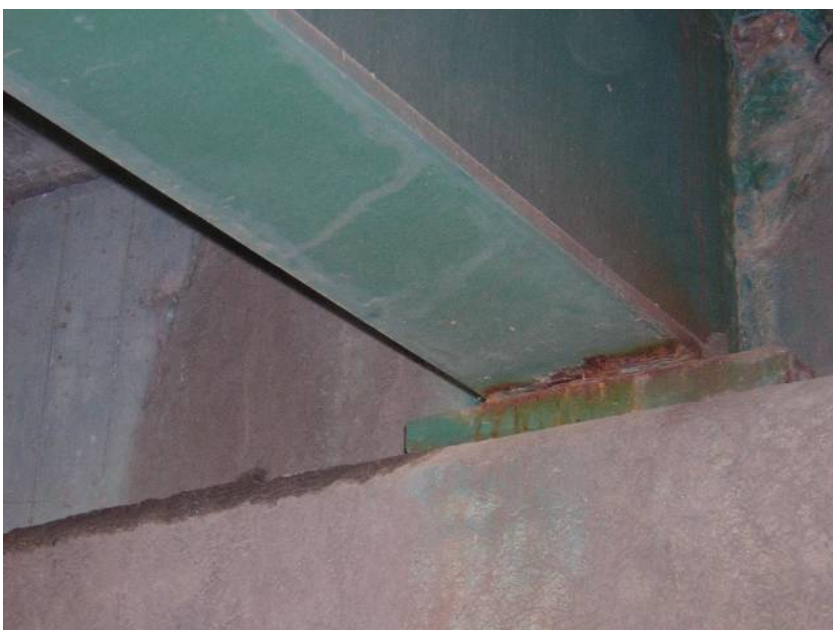
Figure B.5: Typical corrosion in flange (1)

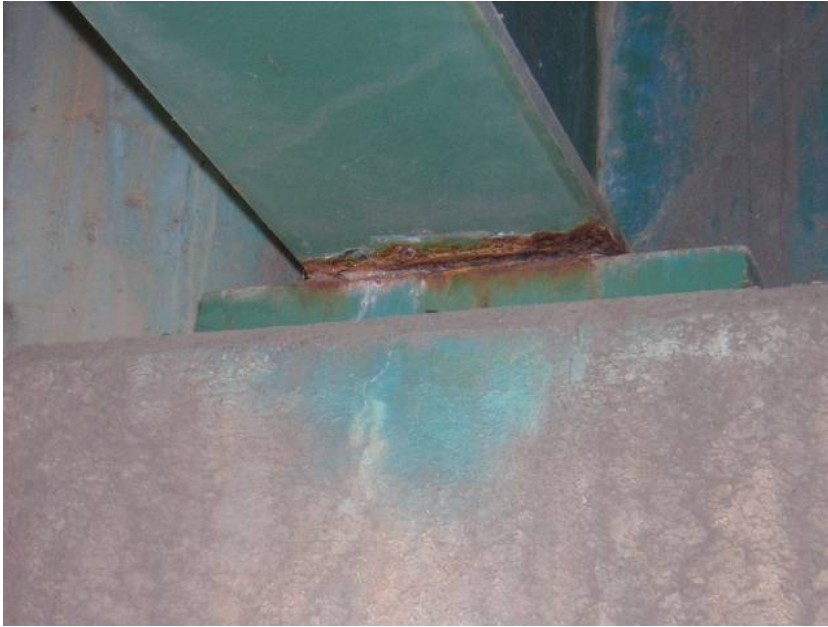
Figure B.6: Typical corrosion in flange (2)

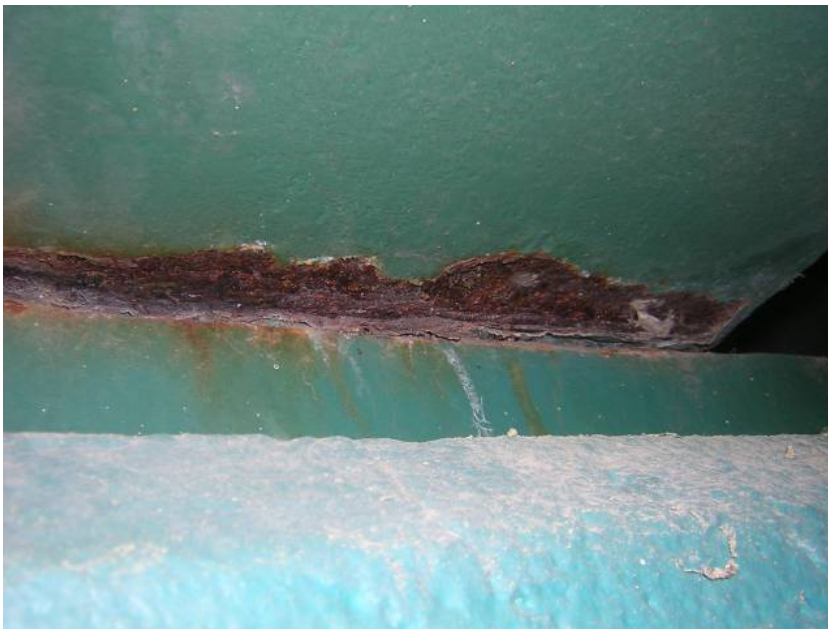
Figure B.7: Close up of crevice corrosion in flange (1)

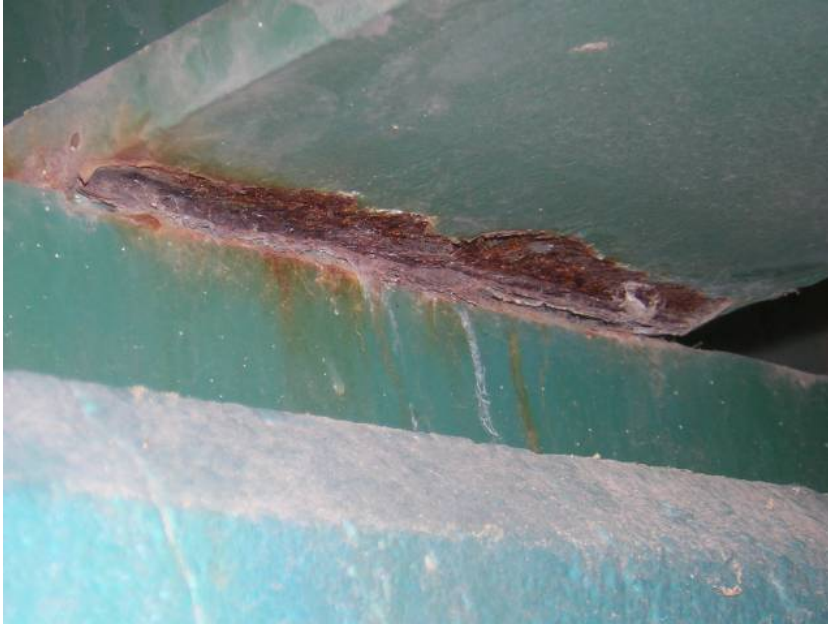
Figure B.8: Close up of crevice corrosion in flange (2)

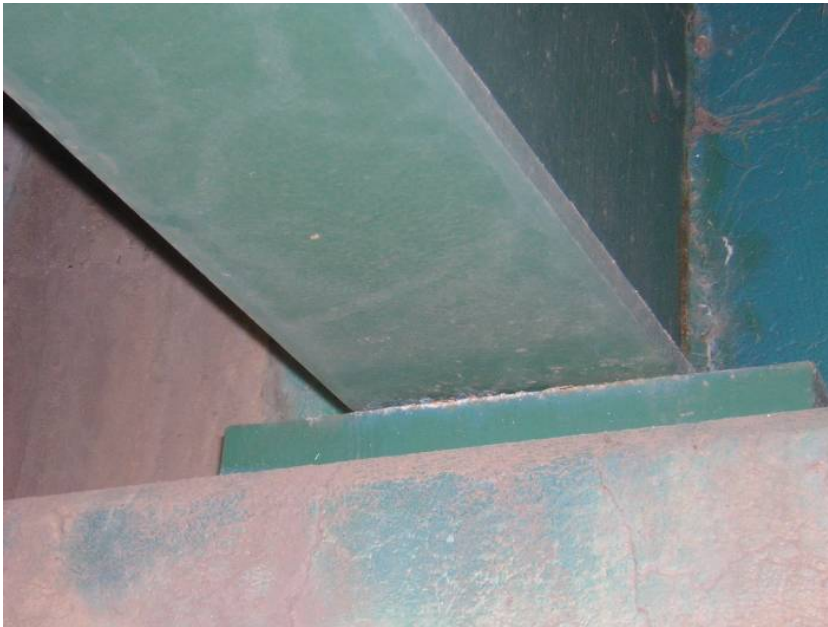
Figure B.9: Interior beams without crevice corrosion

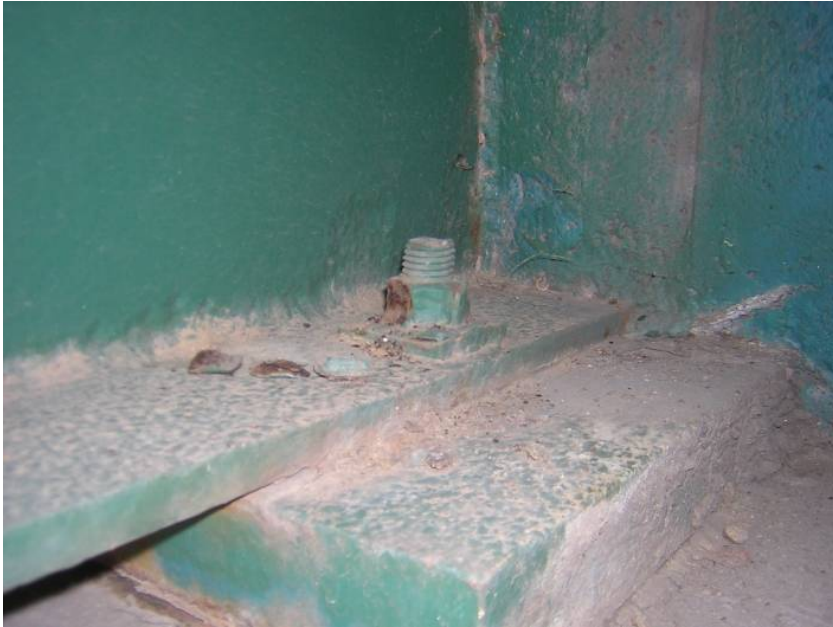
Figure B.10: Corroded nut

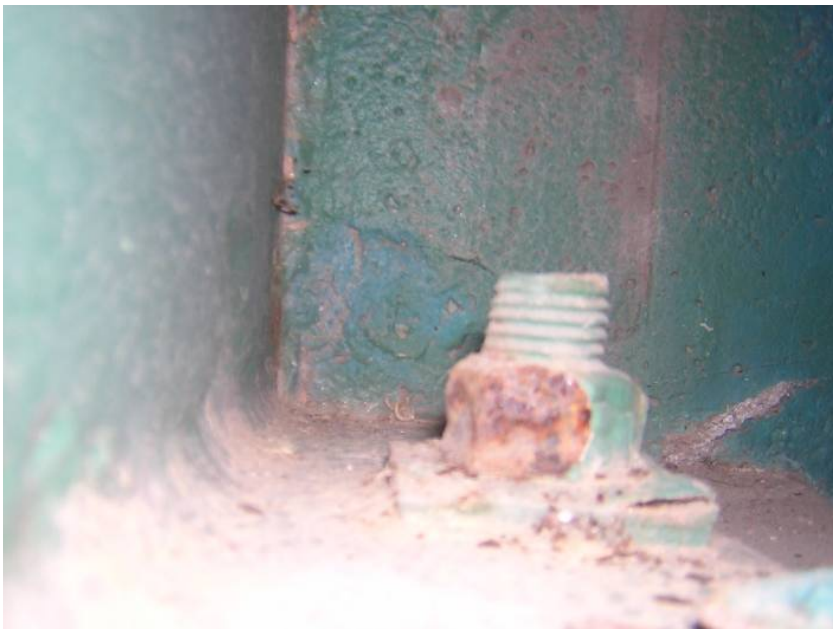
Figure B.11: Close up of corroded nut

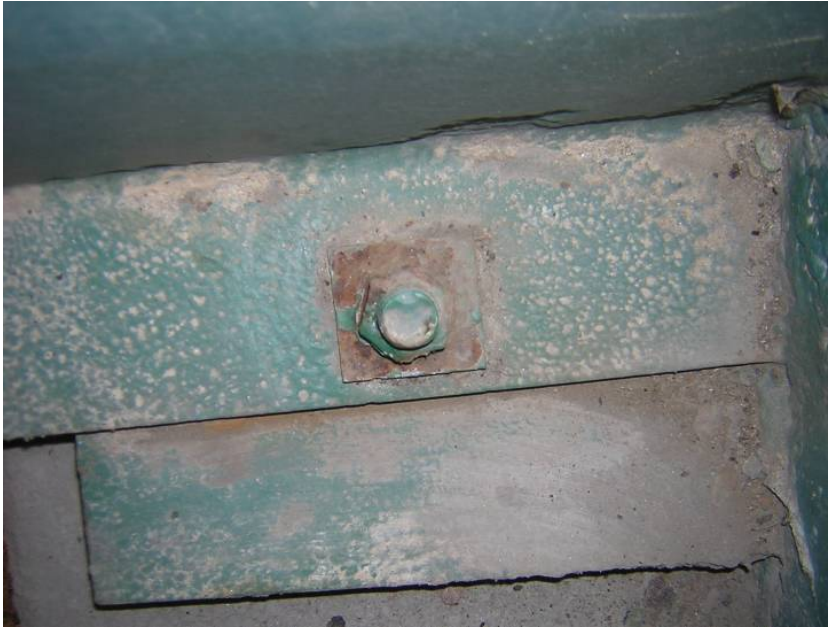
Figure B.12: View from above a typical bolt. Not a pure hexagonal shape.

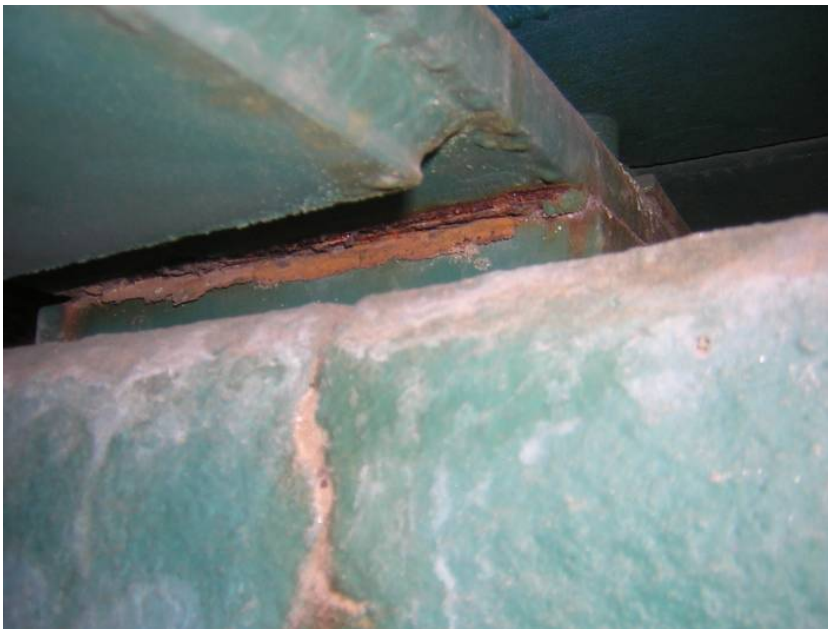
Figure B.15: Crevice corrosion in edge beam at Bent 2.

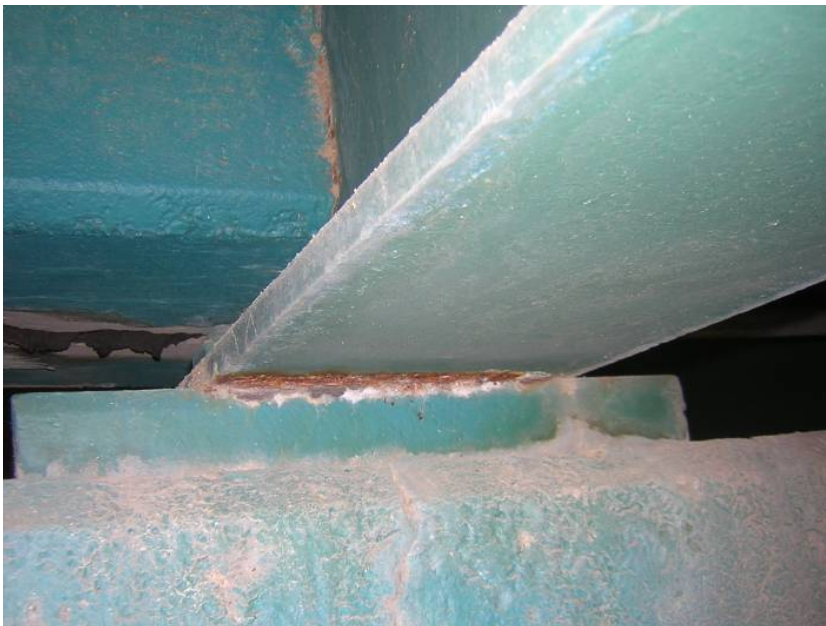
Figure B.17: Crevice corrosion in flange of interior beam at Bent 2.

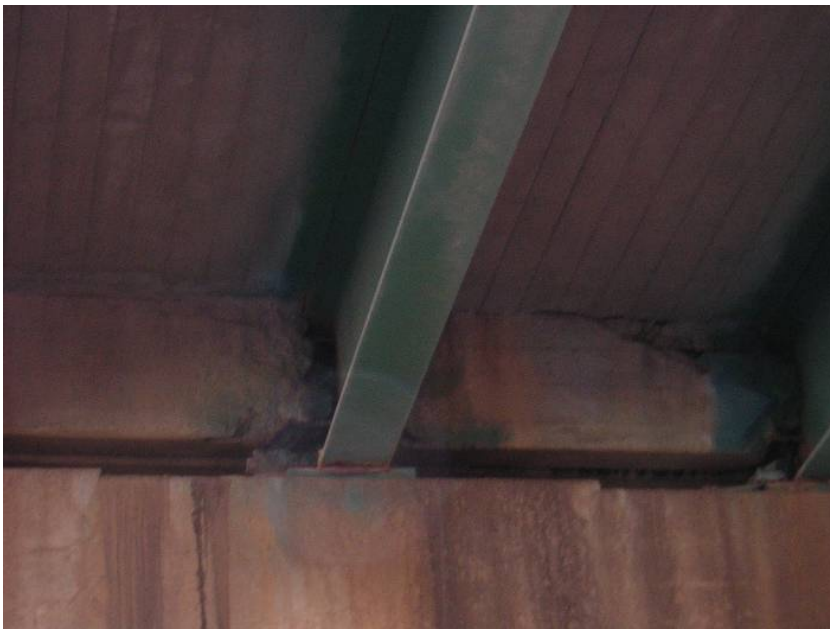
Figure B.19: Spalling diaphragms at interior bent.

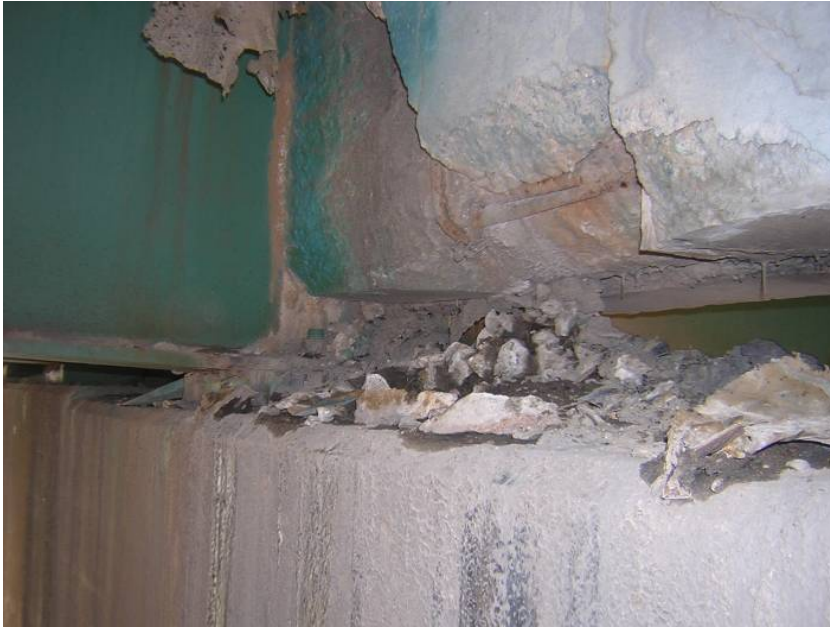
Figure B.20: Debris from diaphragms surrounding bearing

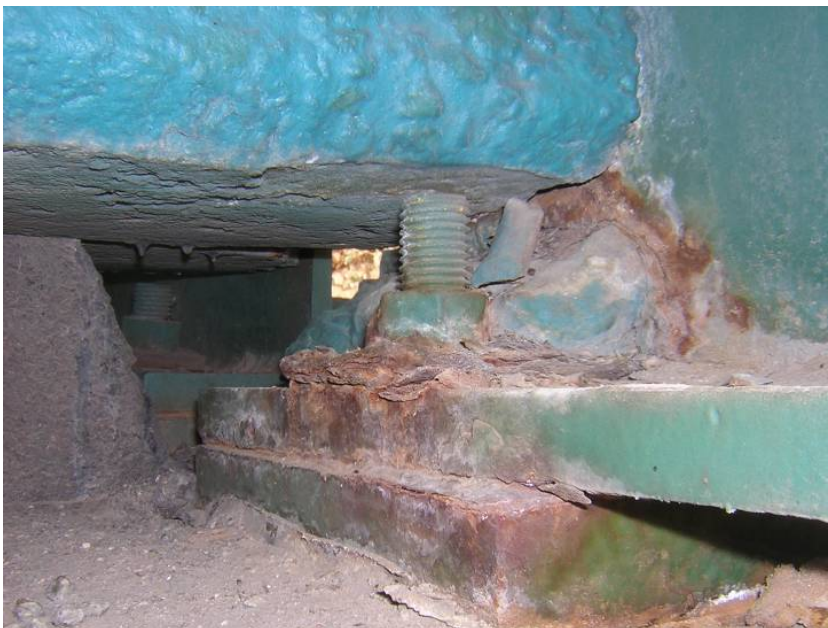
Figure B.24: Corroded bearing at interior Bent 3

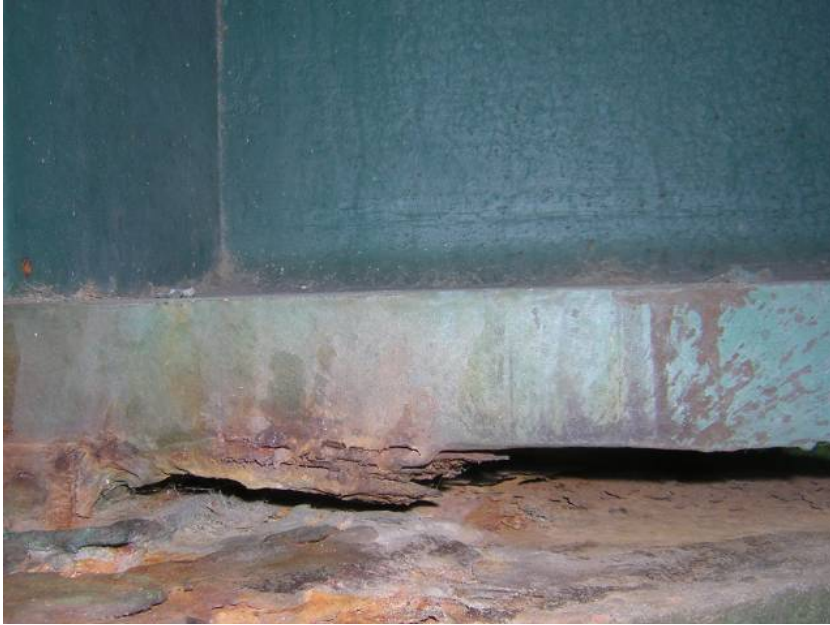
Figure B.28: Corrosion underneath flange at Bent 4 (1)

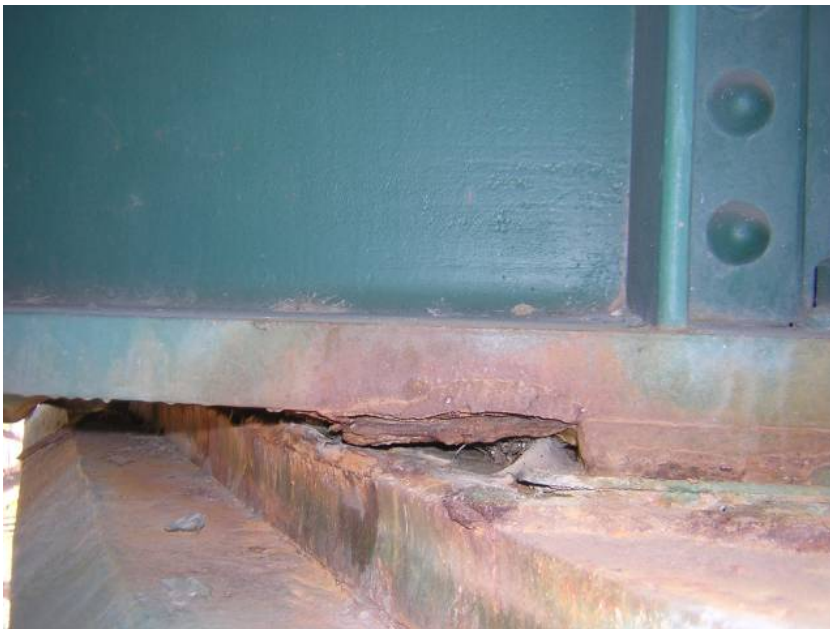
Figure B.29: Corrosion underneath flange at Bent 4 (2)

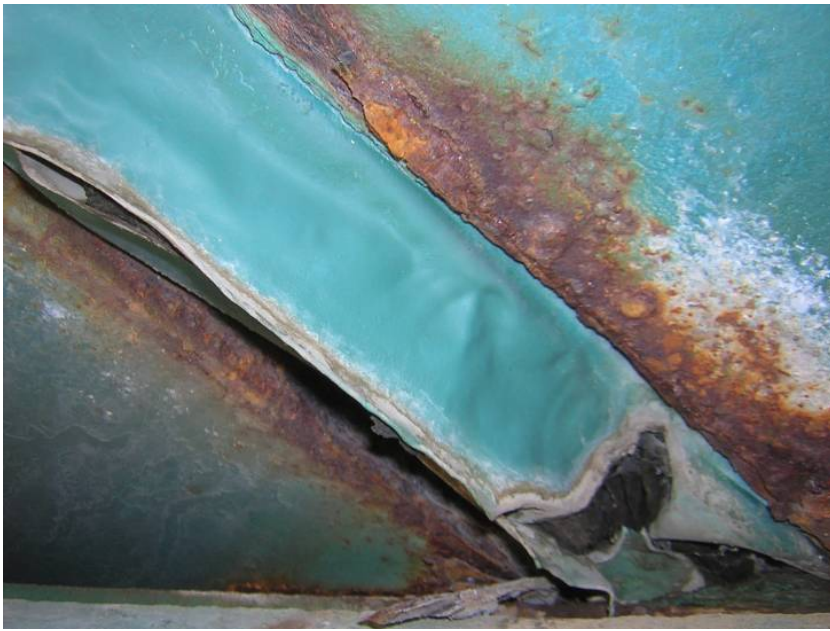
Figure B.31: Corrosion around joint material at Bent 4

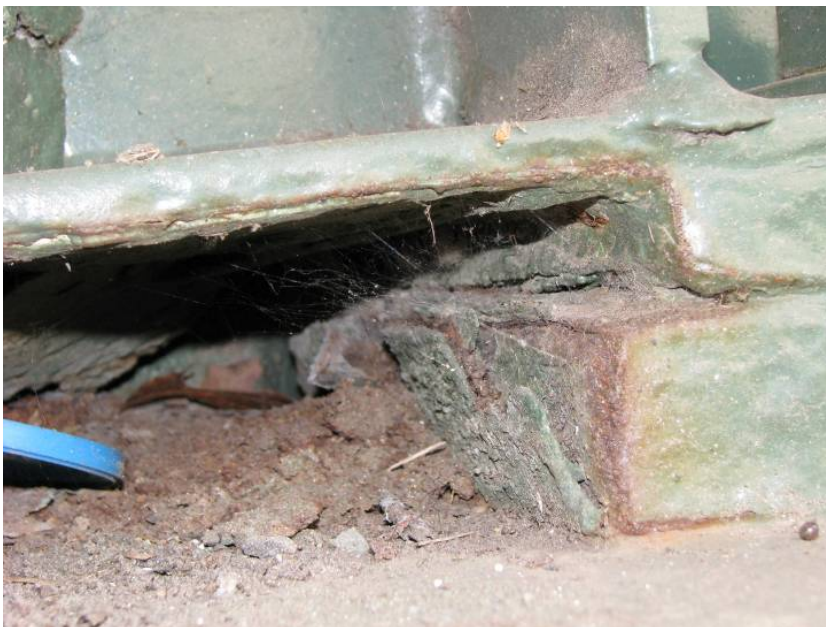
Figure B.39: Corrosion of edge beam bearing at abutment (2)

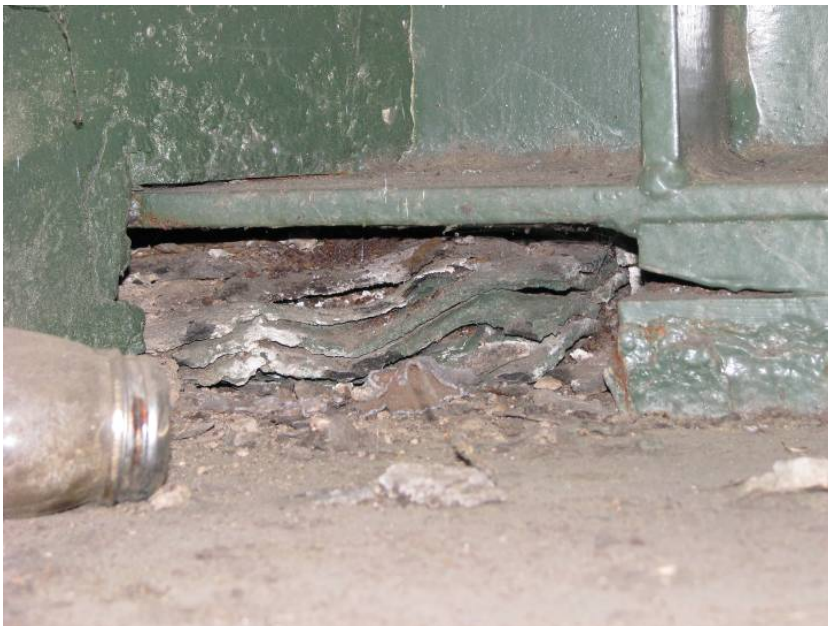
Figure B.47: Degradation of material behind fixed bearing

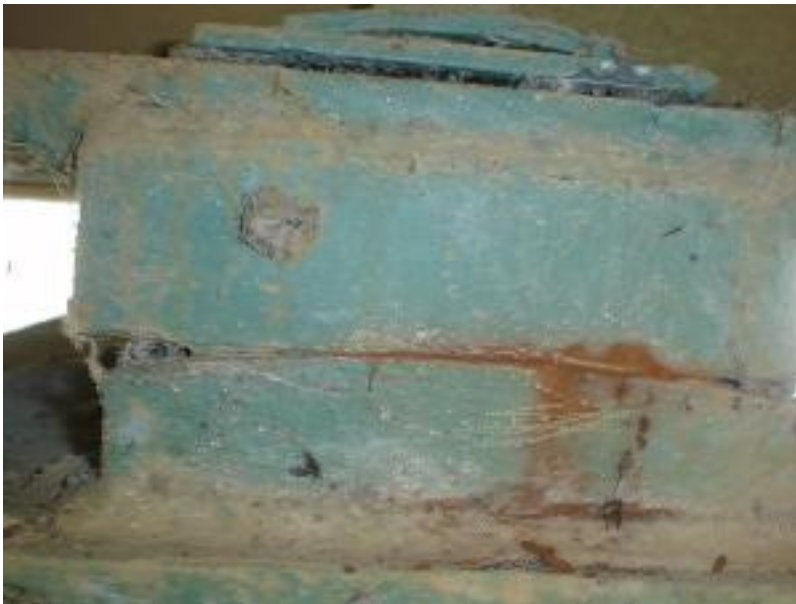
Figure B.105: Close up of corrosion between bearing plates in the fixed rocker

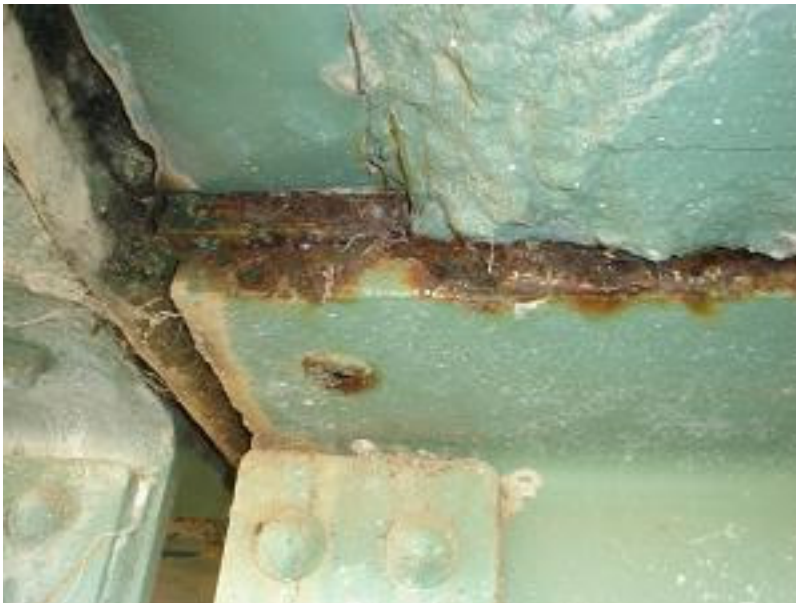
Figure B.107: Close-up of corrosion at deck joint above link bearing

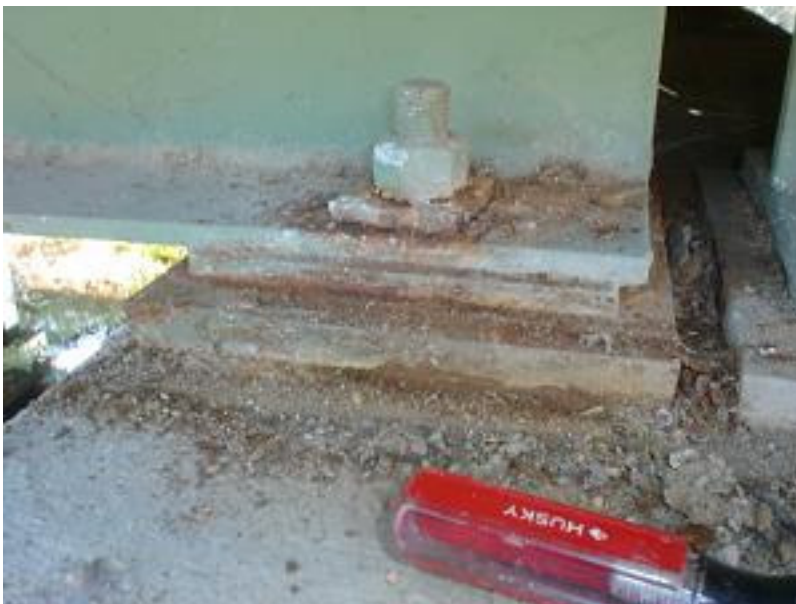
Figure B.111: Bearing corrosion at deck joint

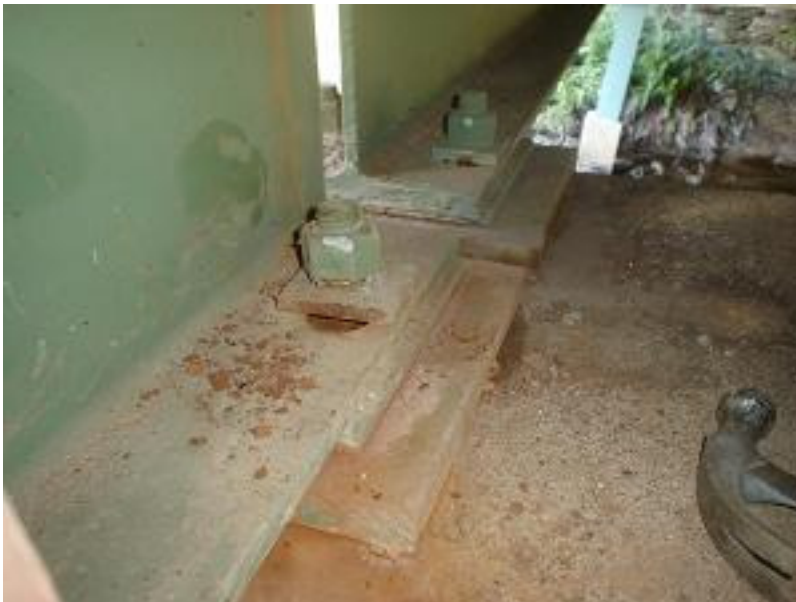
Figure B.113: Investigation of anchor bolt shaft within the bearing by clearing away dirt

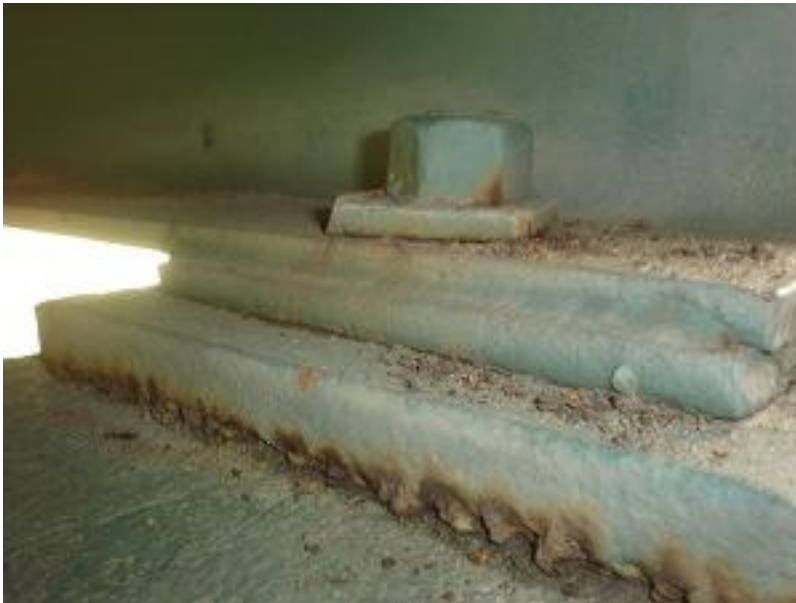
Figure B.122: Expansion bearing at deck joint with visible corrosion on bearing plates
